4450-B PRELIMINARY GEOTECHNICAL MEMORANDUM

City of Oregon City
625 Center Street
Oregon City, OR 97045

**SUBJECT: Preliminary Geotechnical Memorandum
Trillium Park Drive Landslide
Oregon City, Oregon**

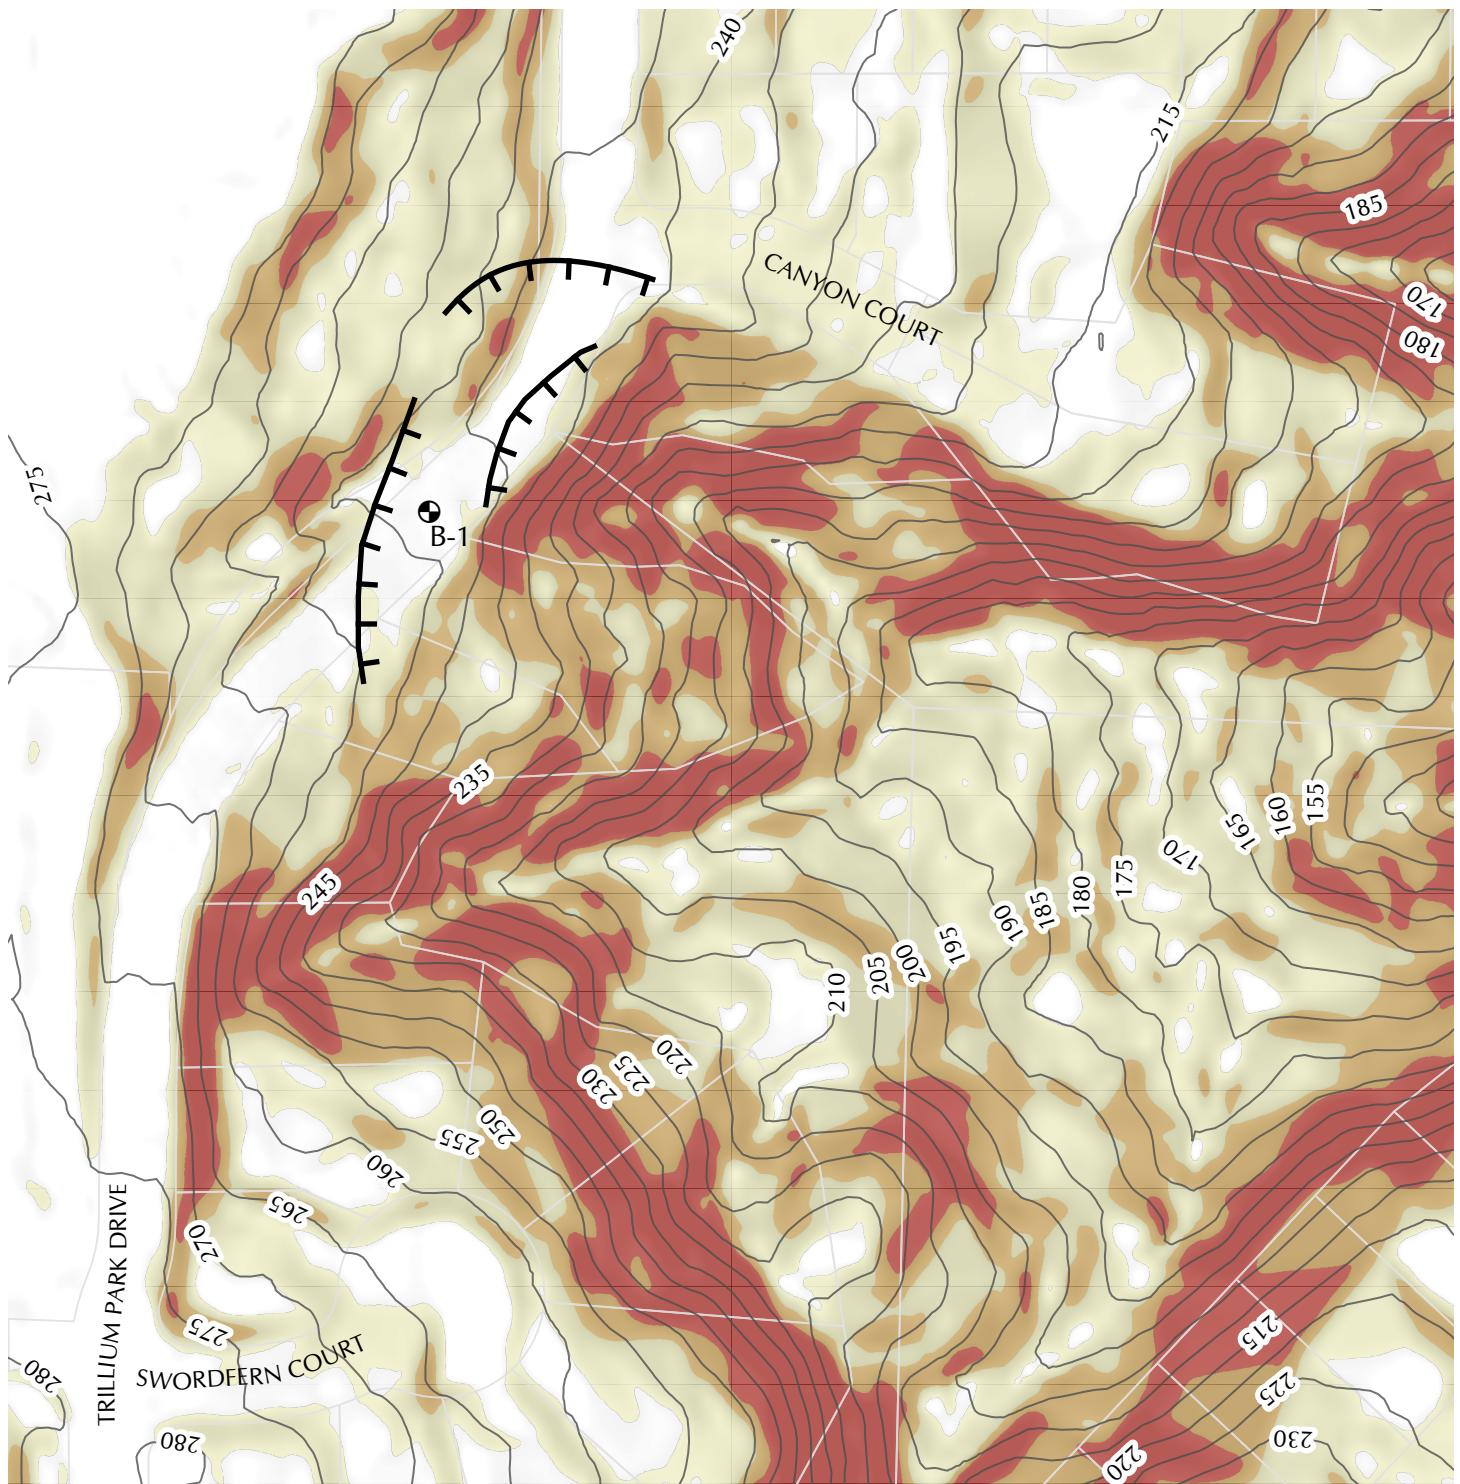
FIG. 2

The site has two sets of concentric, curvilinear ground cracks that cross the road in roughly semi-circular shapes with the open side of the circle pointing downslope (east). One set forms an inner half-circle arc

with an apex about 14 ft from the eastern sidewalk. The limits of the inner set of ground cracks begin about 18 ft south of a catch basin located on the east side of the road near the intersection with Canyon Court and end about 20 ft north of boring B-1. The second half-circle set forms the outer ring of ground cracks, with an apex about 50 ft from the east sidewalk curb. The southern portion of this set of ground cracks was also observed by GRI in 2006, see Figure 2. Ground cracks in this area are visible on Google Street View photography collected in approximately August 2012.

In 2017, the southern limits of the ground cracks could be observed approximately 50 ft onto the undeveloped lot to the southeast of Trillium Park Drive. The outer ring of ground cracks could be followed from the east sidewalk to just east of a stormwater catch basin (west of Trillium Park Drive) but were obscured by vegetation north of this catch basin. Ground cracks were again visible about 15 ft west of a short concrete-block wall and continued to arc eastward toward the road to just west of a catch basin on the west side of the road near the intersection with Canyon Court.

T APPROXIMATE LOCATION OF GROUNDCRACKS

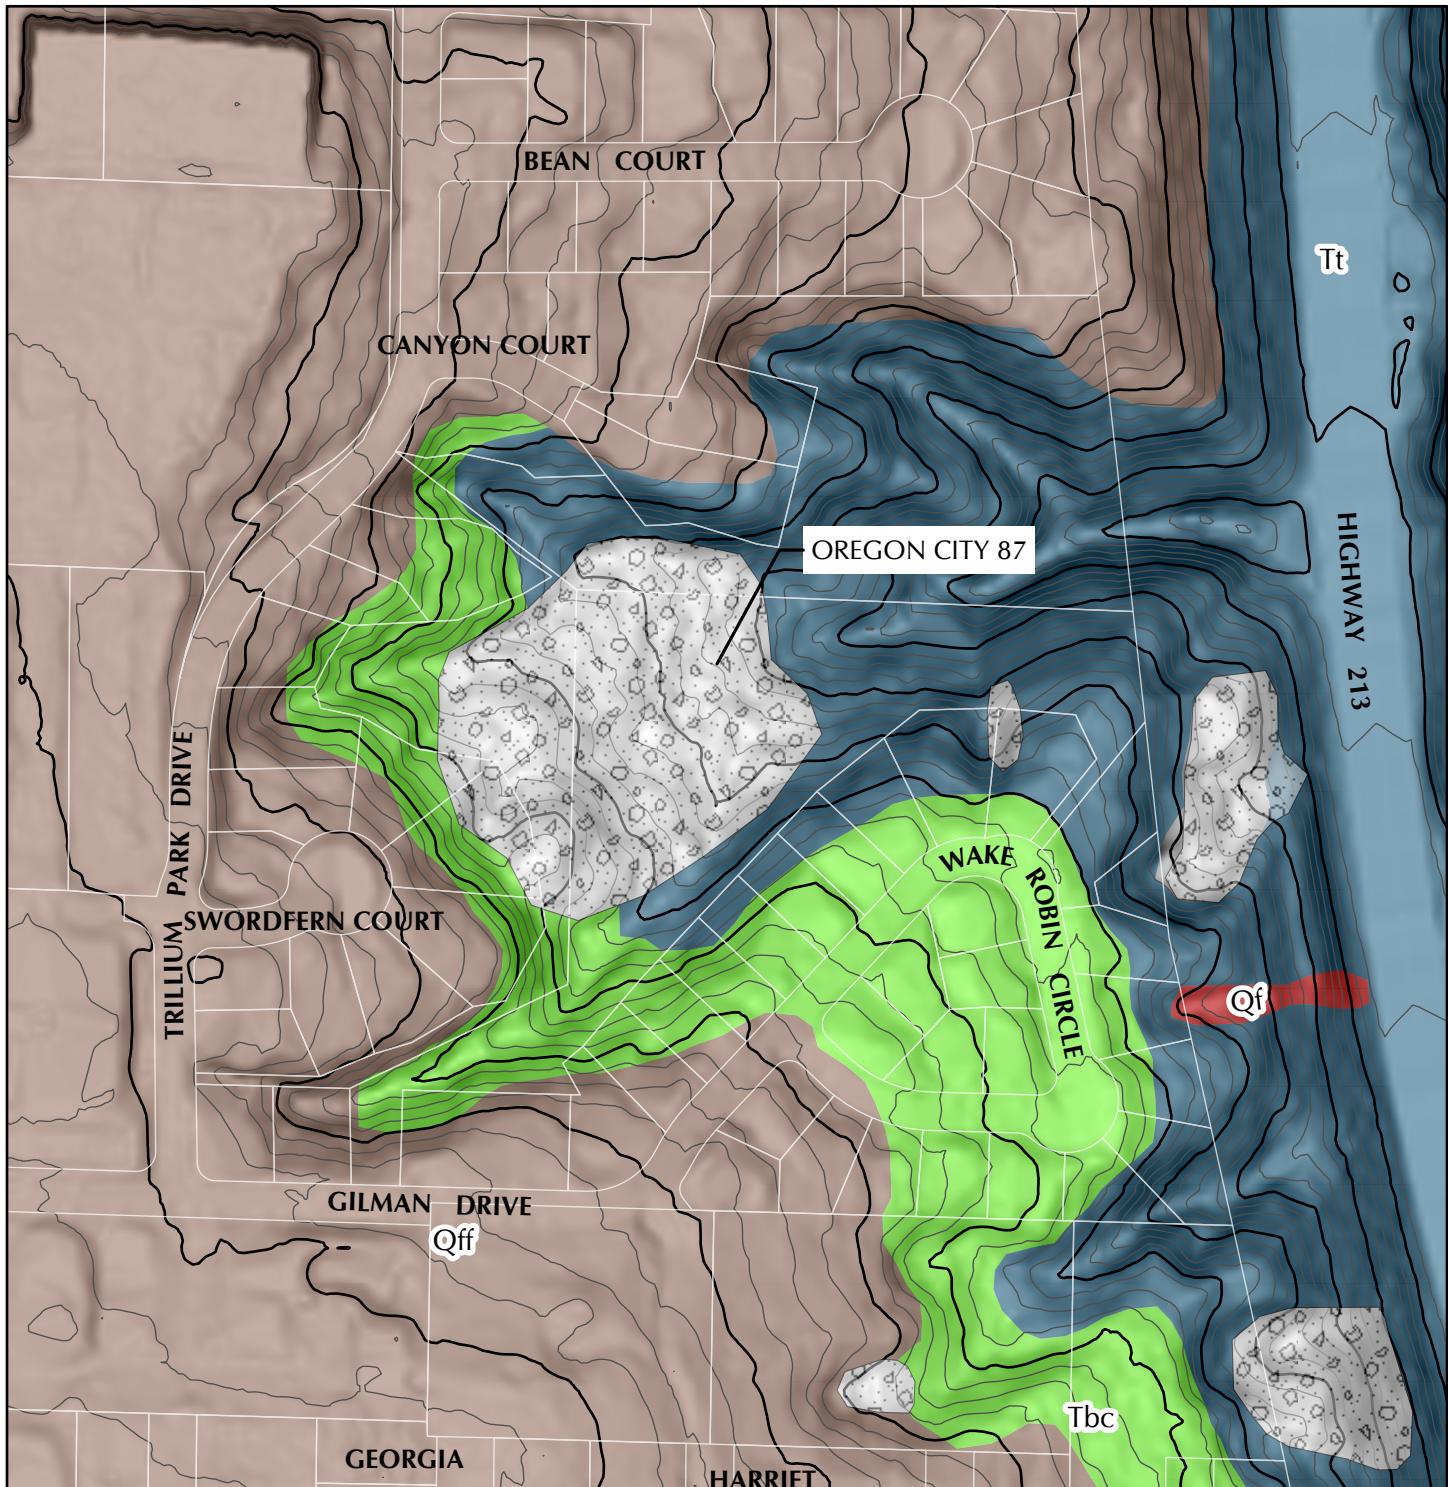
GEOLOGIC MAP

The contact between the Troutdale Formation and the Boring Lava is an erosional surface where the top of the Troutdale Formation has been eroded and infilled by the Boring Lava. This erosional surface produces an undulating contact in the top of the Troutdale Formation that varies in elevation where it is exposed at the ground surface. The most recent geologic mapping of the area indicates the contact of the Troutdale Formation varies in elevation from about 140 ft along the slope above OR-213 to 225 ft near the residence at 13776 Canyon Court. The Boring Lava is mapped along the slope just below Trillium Park Drive. The Willamette Silt is mapped at the surface of the landslide and along higher elevations near the site (Madin, 2009), as presented on the Geologic Map, Figure 3.

The Newell Canyon area is prone to landslides that occur from erosion by Newell Creek, which have exposed the contact of the Troutdale Formation and Boring Lava. The failure plane of the Trillium Park Drive landslide appears to coincide with the exposed contact of weak, relatively impermeable sedimentary rock and the underling hard basalt rock, similar to other landslides in the Newell Creek drainage.

The Oregon Department of Geology and Mineral Industries (DOGAMI) has produced maps showing areas of known landslides or areas with ground features indicative of landslide processes, termed “landslide topography.” At the time of this report, the project site has not been mapped within the boundary of landslide topography (Burns and Watzig, 2014). However, a landslide was identified by DOGAMI near the Trillium Park Drive landslide and is shown on Figure 3 (“QIs” deposits shown as Oregon City 87 on Figure 3).

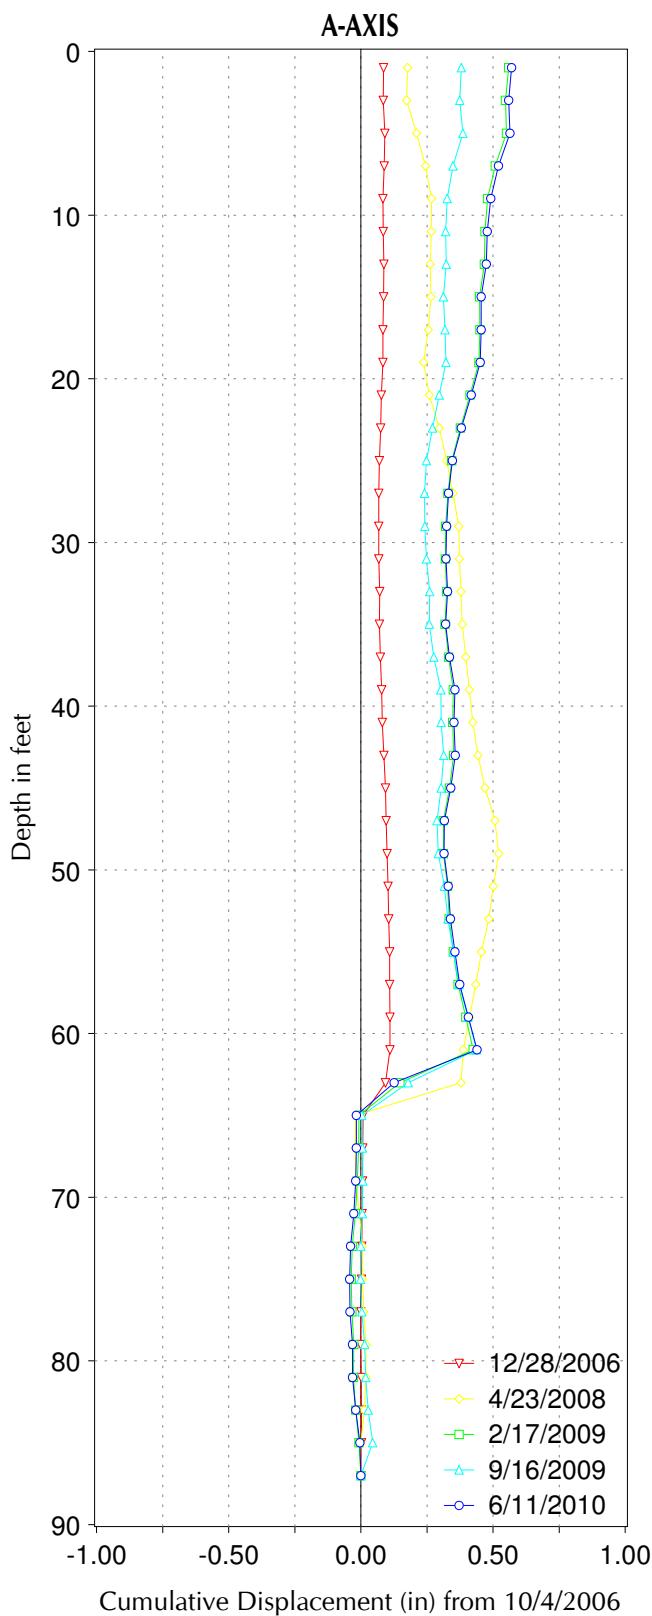
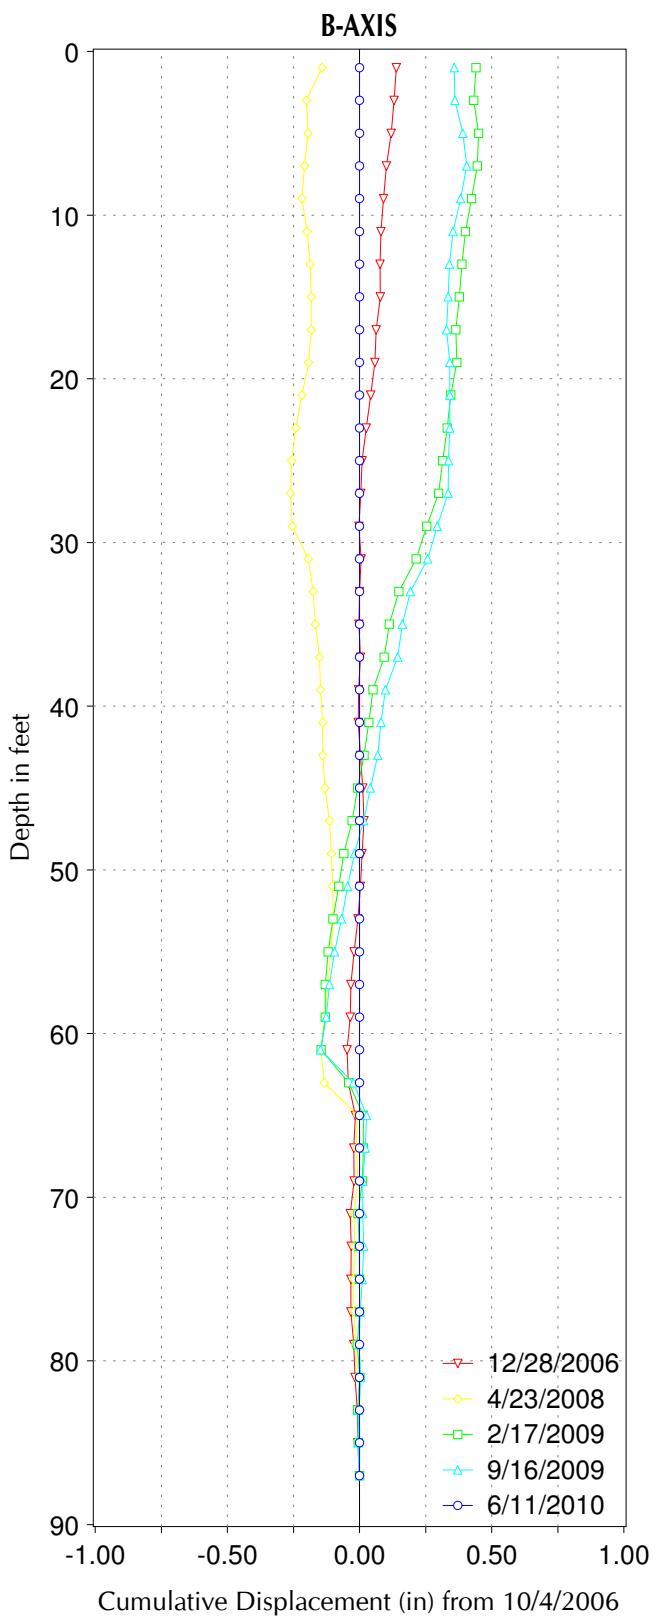
INCLINOMETER SUMMARY
(BORING B-1)

The slope inclinometer monitoring performed by GRI in boring B-1 between the initialization date of October 4, 2006, and June 11, 2010, indicates a maximum lateral movement of about 0.5 in. occurred at a depth of approximately 65 ft below the ground surface. Inclinometer monitoring results are provided in Figure 4. In March 2017, the City evaluated the inclinometer with a video camera and found the inclinometer casing sheared at a depth of about 61.8 ft. The amount of lateral movement that sheared the casing could not be determined from the video.

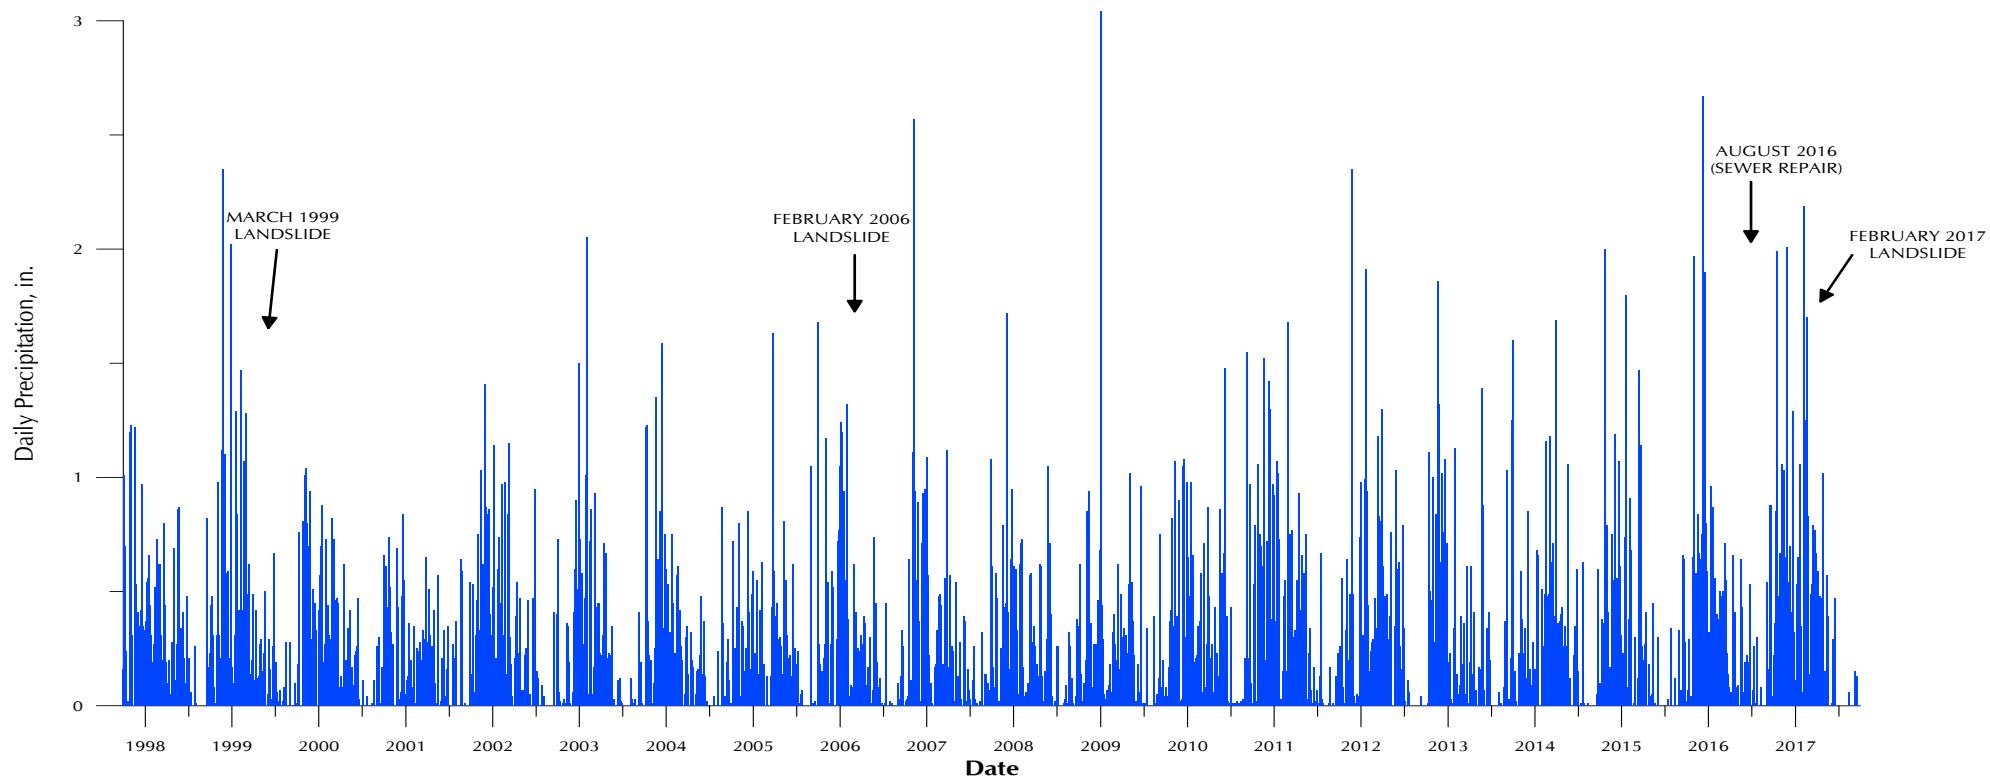
FIG. 6

A graph of daily precipitation between 1998 and 2017 for the Portland area is shown on Figure 6. Figure 6 also shows the landslide events in March 1999 and February 2006, the sewer repair in August 2016, and the February 2017 landslide.

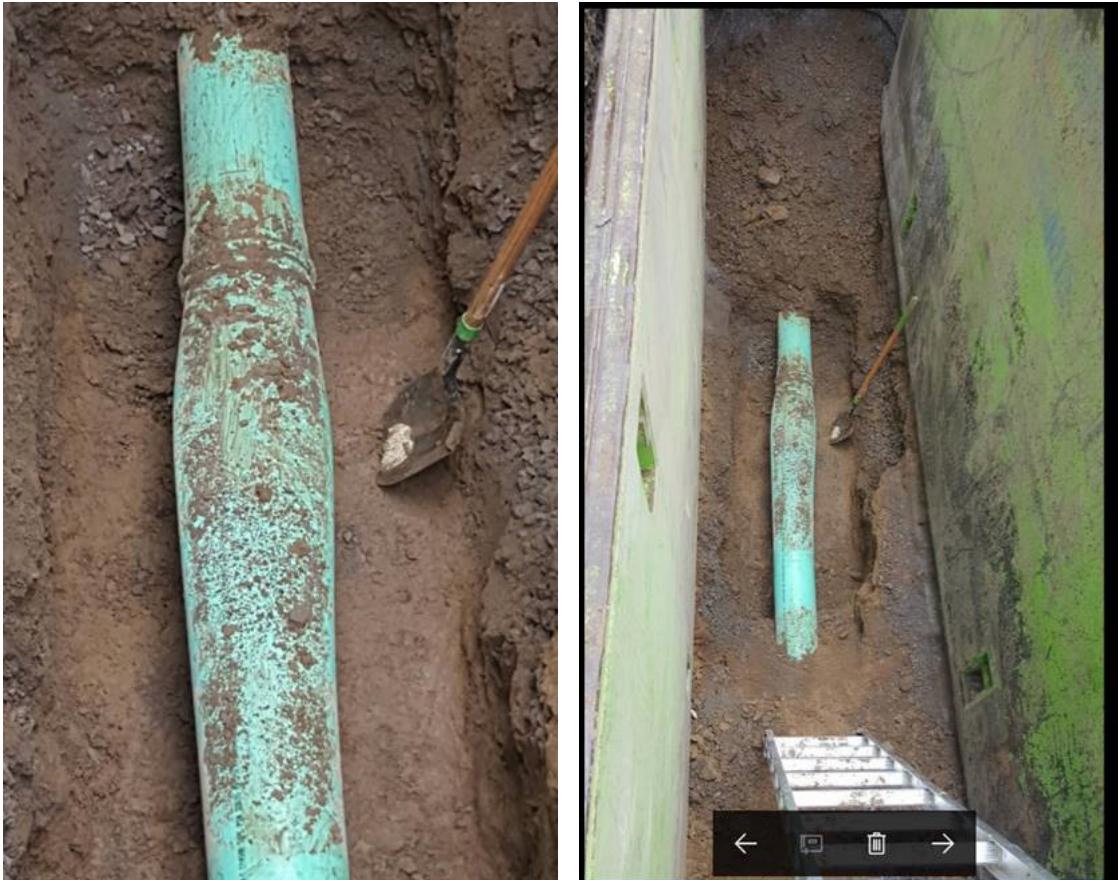
In August 2016, City forces observed a deformation in the 8-in. diameter PVC pipe in Trillium Park Drive. The area was excavated and the deformed section of pipe repaired. Details regarding the pipe repair are provided in Appendix B.

- August 2016:
 - Video survey just prior to City's August 2016 pavement maintenance project on Trillium Park Drive, a small section of City's underground 8-inch PVC sanitary sewer pipe was found to be deformed from a circular pipe to an oblong pipe.
 - This PVC pipe piece was removed and replaced with a length of HDPE pipe and two Romac couplings prior to the pavement maintenance work.
- August 2017:
 - Video survey performed of City's underground 8-inch sanitary sewer pipe in Trillium Park Drive and was found to be deformed from a circular pipe to an oblong pipe in the same location that found in 2016 a similar deformed pipe section that had been replaced in 2016.
- Below shows the 2016 deformed PVC section.

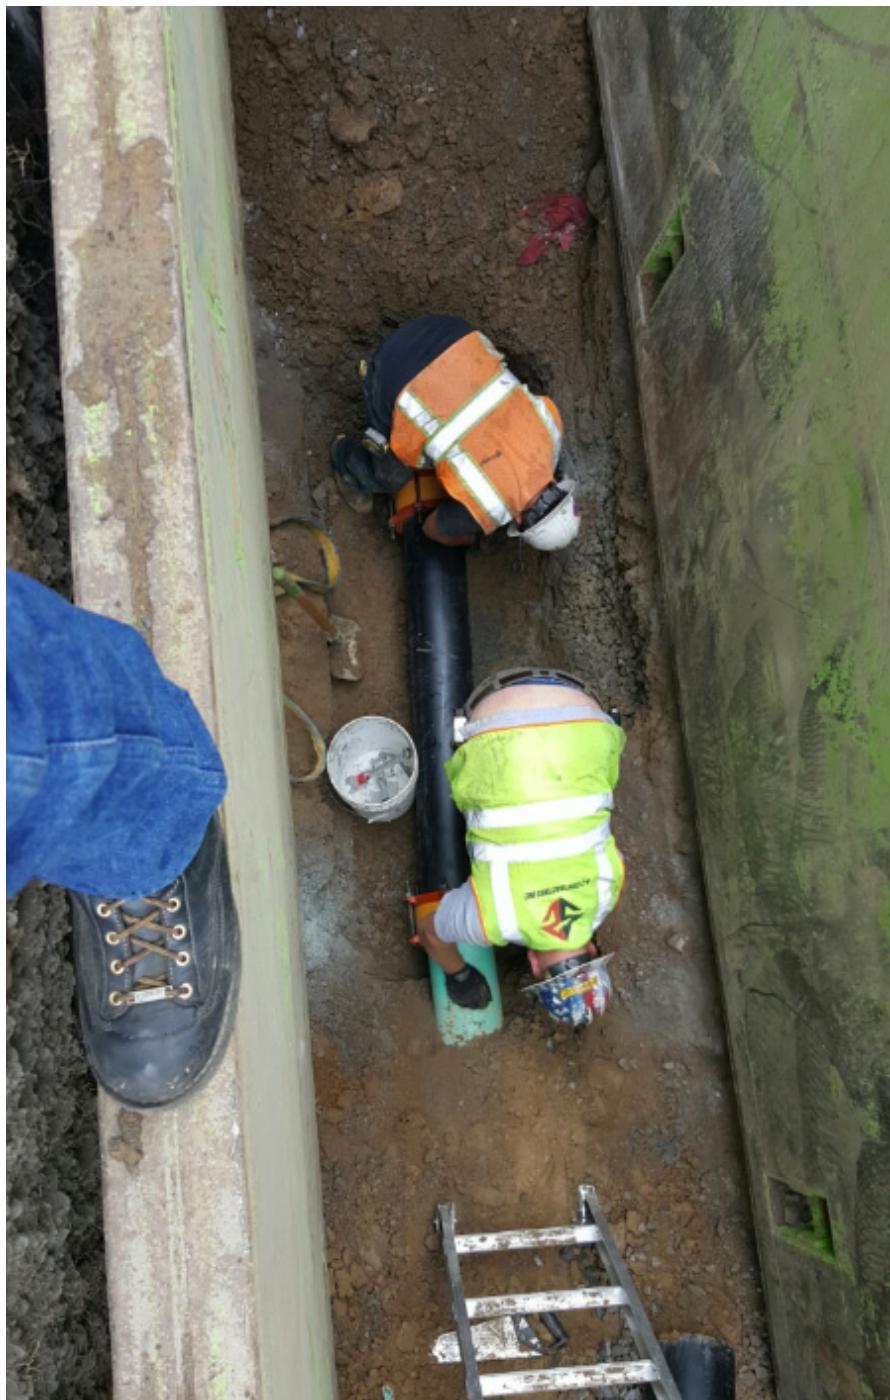
- Below shows the 2016 HDPE Replacement pipe section with the Romac couplings.
