SITE VISIT REPORT

Project:	Trillium Park Drive Landslide	Date:	December 18, 2017	Project No.:	4450
Feature:	Sewer Repair	Time of Site Visit:	9:15 AM – 4:30 PM		
Client:	City of Oregon City	Weather:	Cool, breezy, misting in afternoon		
Site Address:	17300 block of Trillium Park Drive	Submitted by:	Michael Zimmerman, PE, GE, CEG		
		Contractor:	Sanitech LLC

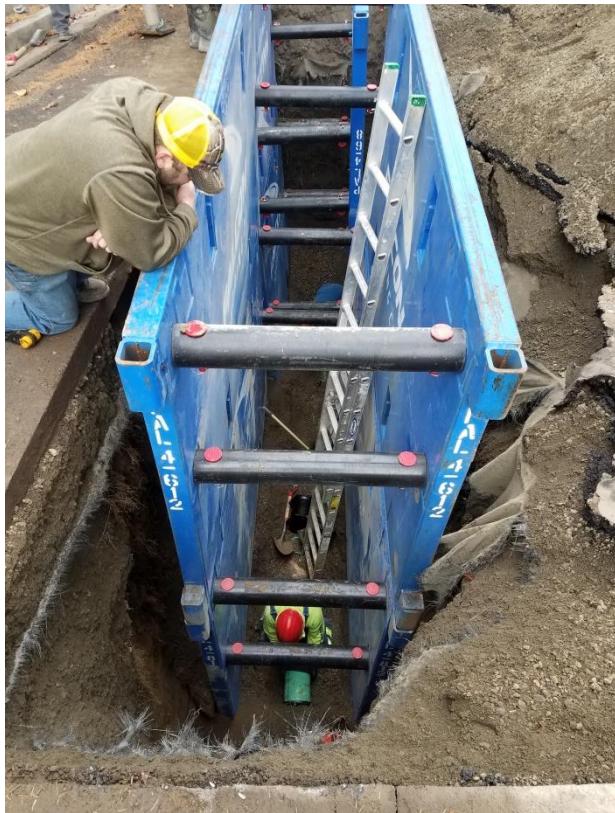
Once the entire section of the HDPE pipe from the previous repair was exposed, it was apparent the pipe within the landslide has moved down and to the right when viewed looking to the northeast down the gradient of the pipe. The replacement segment of pipe has slip joints at both ends, two 11° bends, and a slip joint near the midpoint between the two bends. The crushed rock base course was compacted using several passes of a “jumping jack” walk-behind compactor prior to placing the new section of pipe. A heavy non-woven geotextile filter fabric was placed beneath the new section of pipe to envelop the pea gravel planned for the pipe zone trench fill. The contractor had pea gravel stockpiled on site for this purpose. GRI recommended the pea gravel should be placed loose.
