SITE VISIT REPORT

Project:	Trillium Park Drive	Date:	February 21, 2017	Project No.:	4450-B
Feature:	Landslide	Time of Site Visit:	1145-100 pm		
		Weather:	Rain		
		Submitted by:	George Freitag, CEG		
Client:	City of Oregon City	Owner:	City of Oregon City		
Site Address:	17300 block of Trillium Park Drive	Building Permit No.	N/A

February 21 Landslide Observations

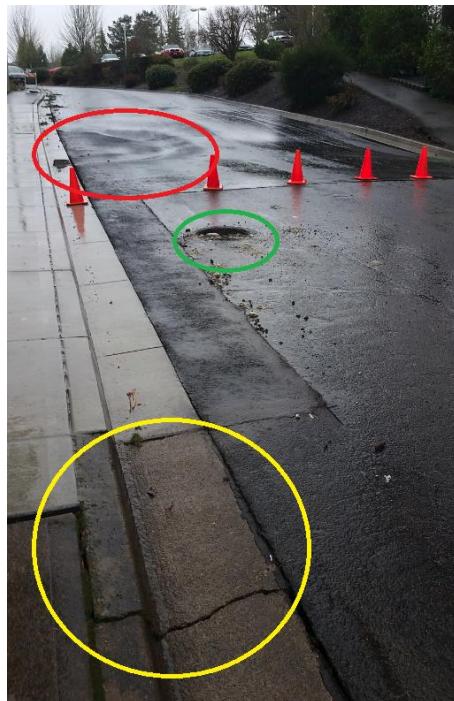
View south of landslide. Red circle shows approximate location of broken water line and inflated/damaged pavement. Green circle shows inclinometer monument. Yellow circle shows pavement cracking and joint separation.

Reviewed the roadway site conditions with Aleta. Recommended the City building official review the conditions at the residence at 13776 Canyon Court. In our opinion, as a short term measure, effort should be made to limit the amount of surface water that can concentrate and flow into the landslide area by means of sealing or rerouting surface water from of pavement cracks or open pavement joints that have separated. Additionally, effort should be made to evaluate the inclinometer and obtain a current reading if the installation is still usable. The condition of the storm and sanitary sewer lines in the roadway that cross the landslide area should be evaluated with video or other means. City staff should periodically evaluate the

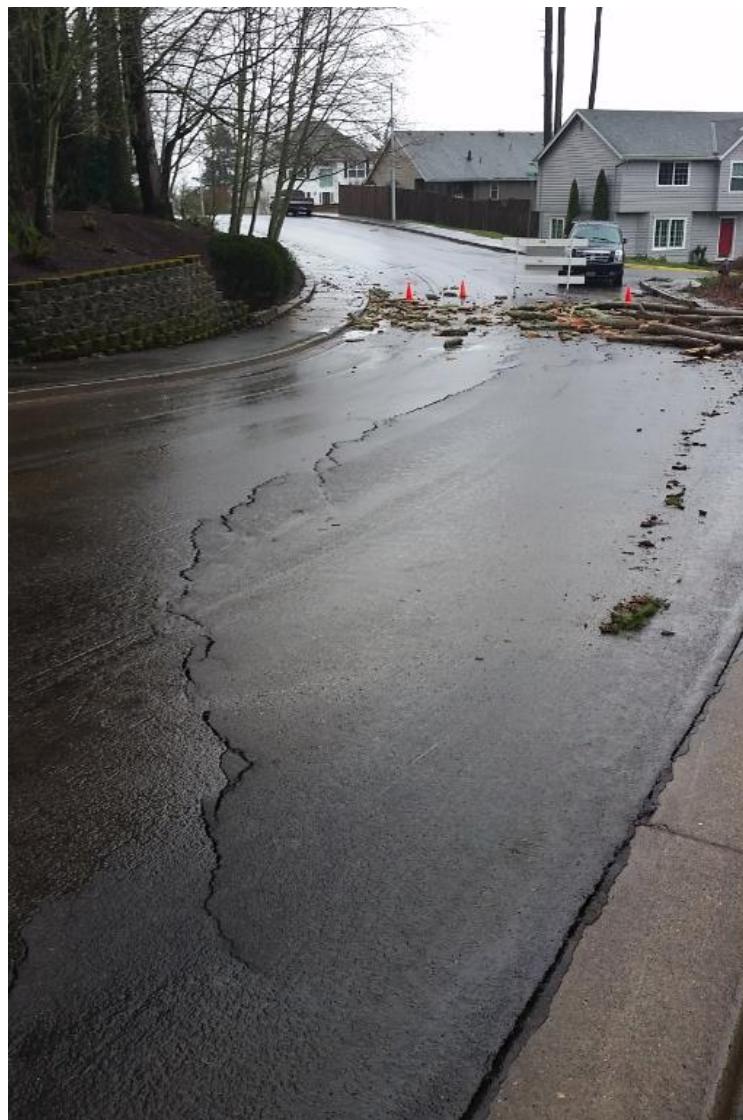
View north showing pavement cracks. Note downed tree pieces in background.

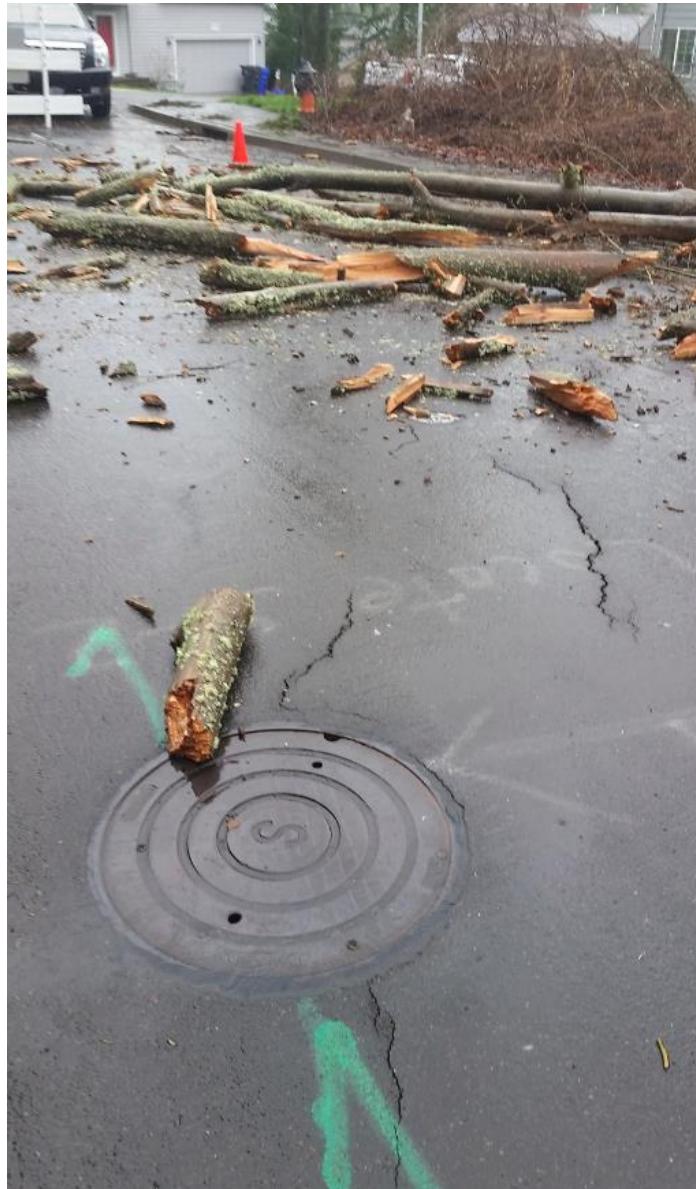
Detail view in north portion of landslide showing pavement cracks around sewer manhole.

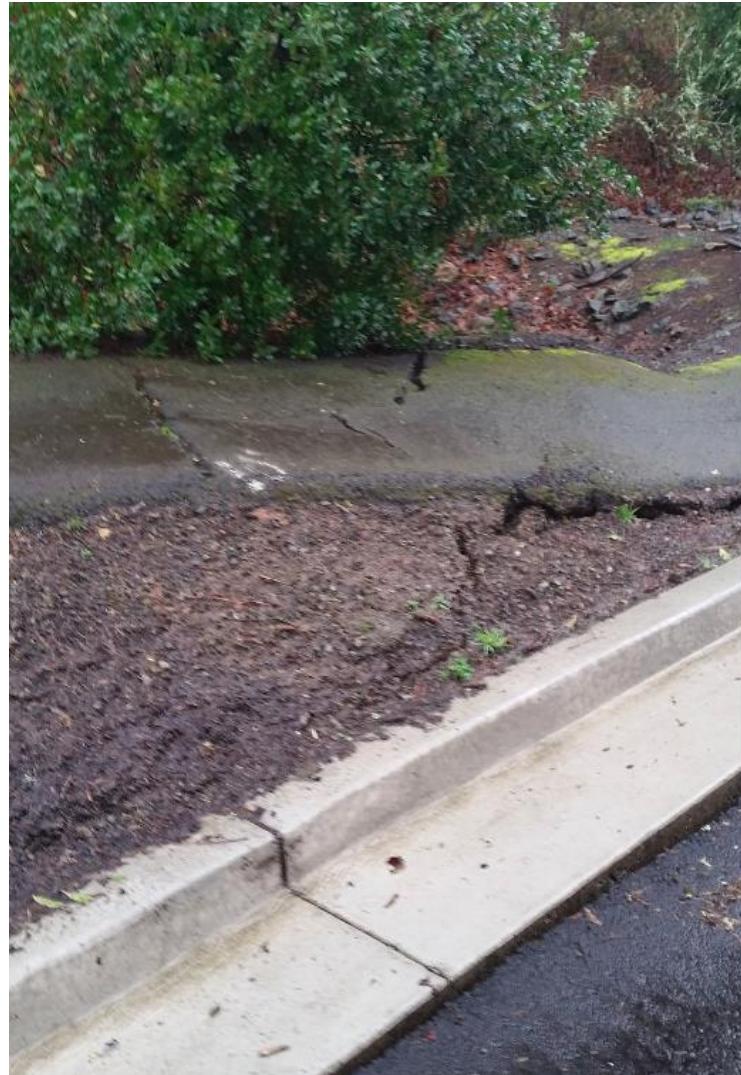
Detail view in west portion of landslide showing pavement cracks in asphalt sidewalk, tension cracks in unpaved dirt area, and joint opening between concrete curb and asphalt roadway.

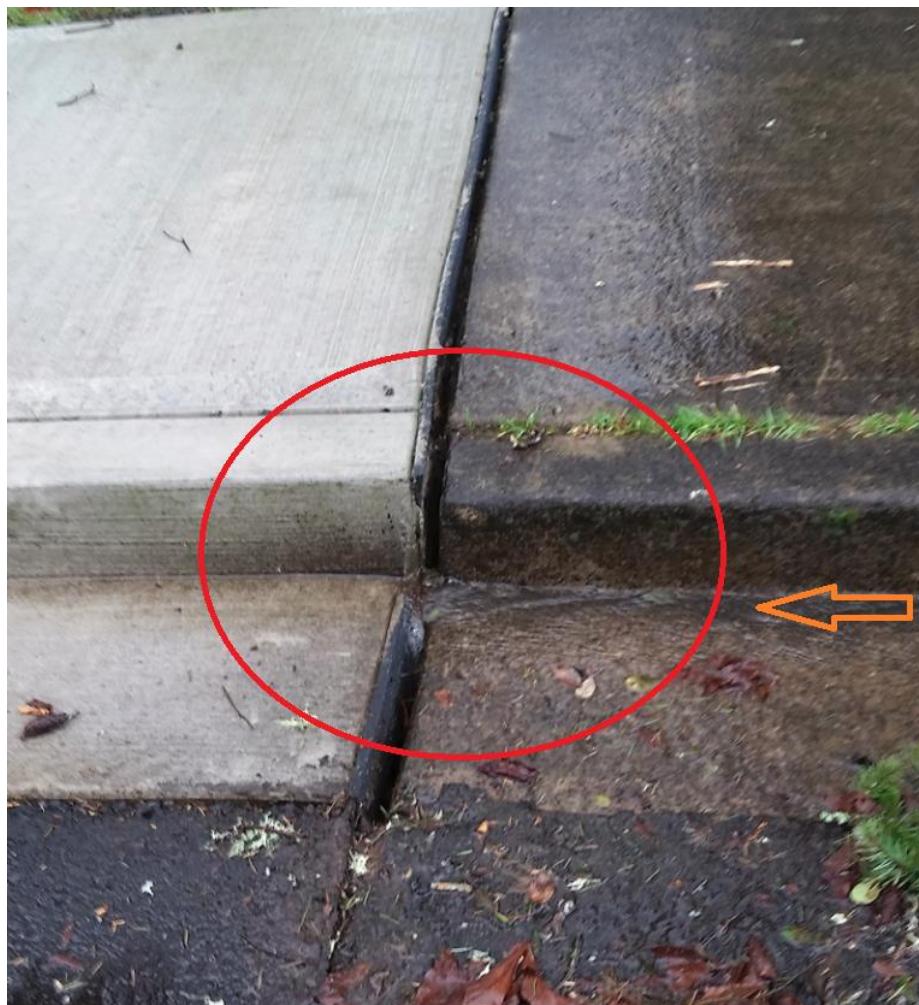
Red circle shows surface water entering uphill (south) portion of landslide along open sidewalk and curb pavement joints. Orange arrow shows direction of water flow from uphill (right).
