4450-B PRELIMINARY GEOTECHNICAL MEMORANDUM

City of Oregon City
625 Center Street
Oregon City, OR 97045

**SUBJECT: Preliminary Geotechnical Memorandum
Trillium Park Drive Landslide
Oregon City, Oregon**

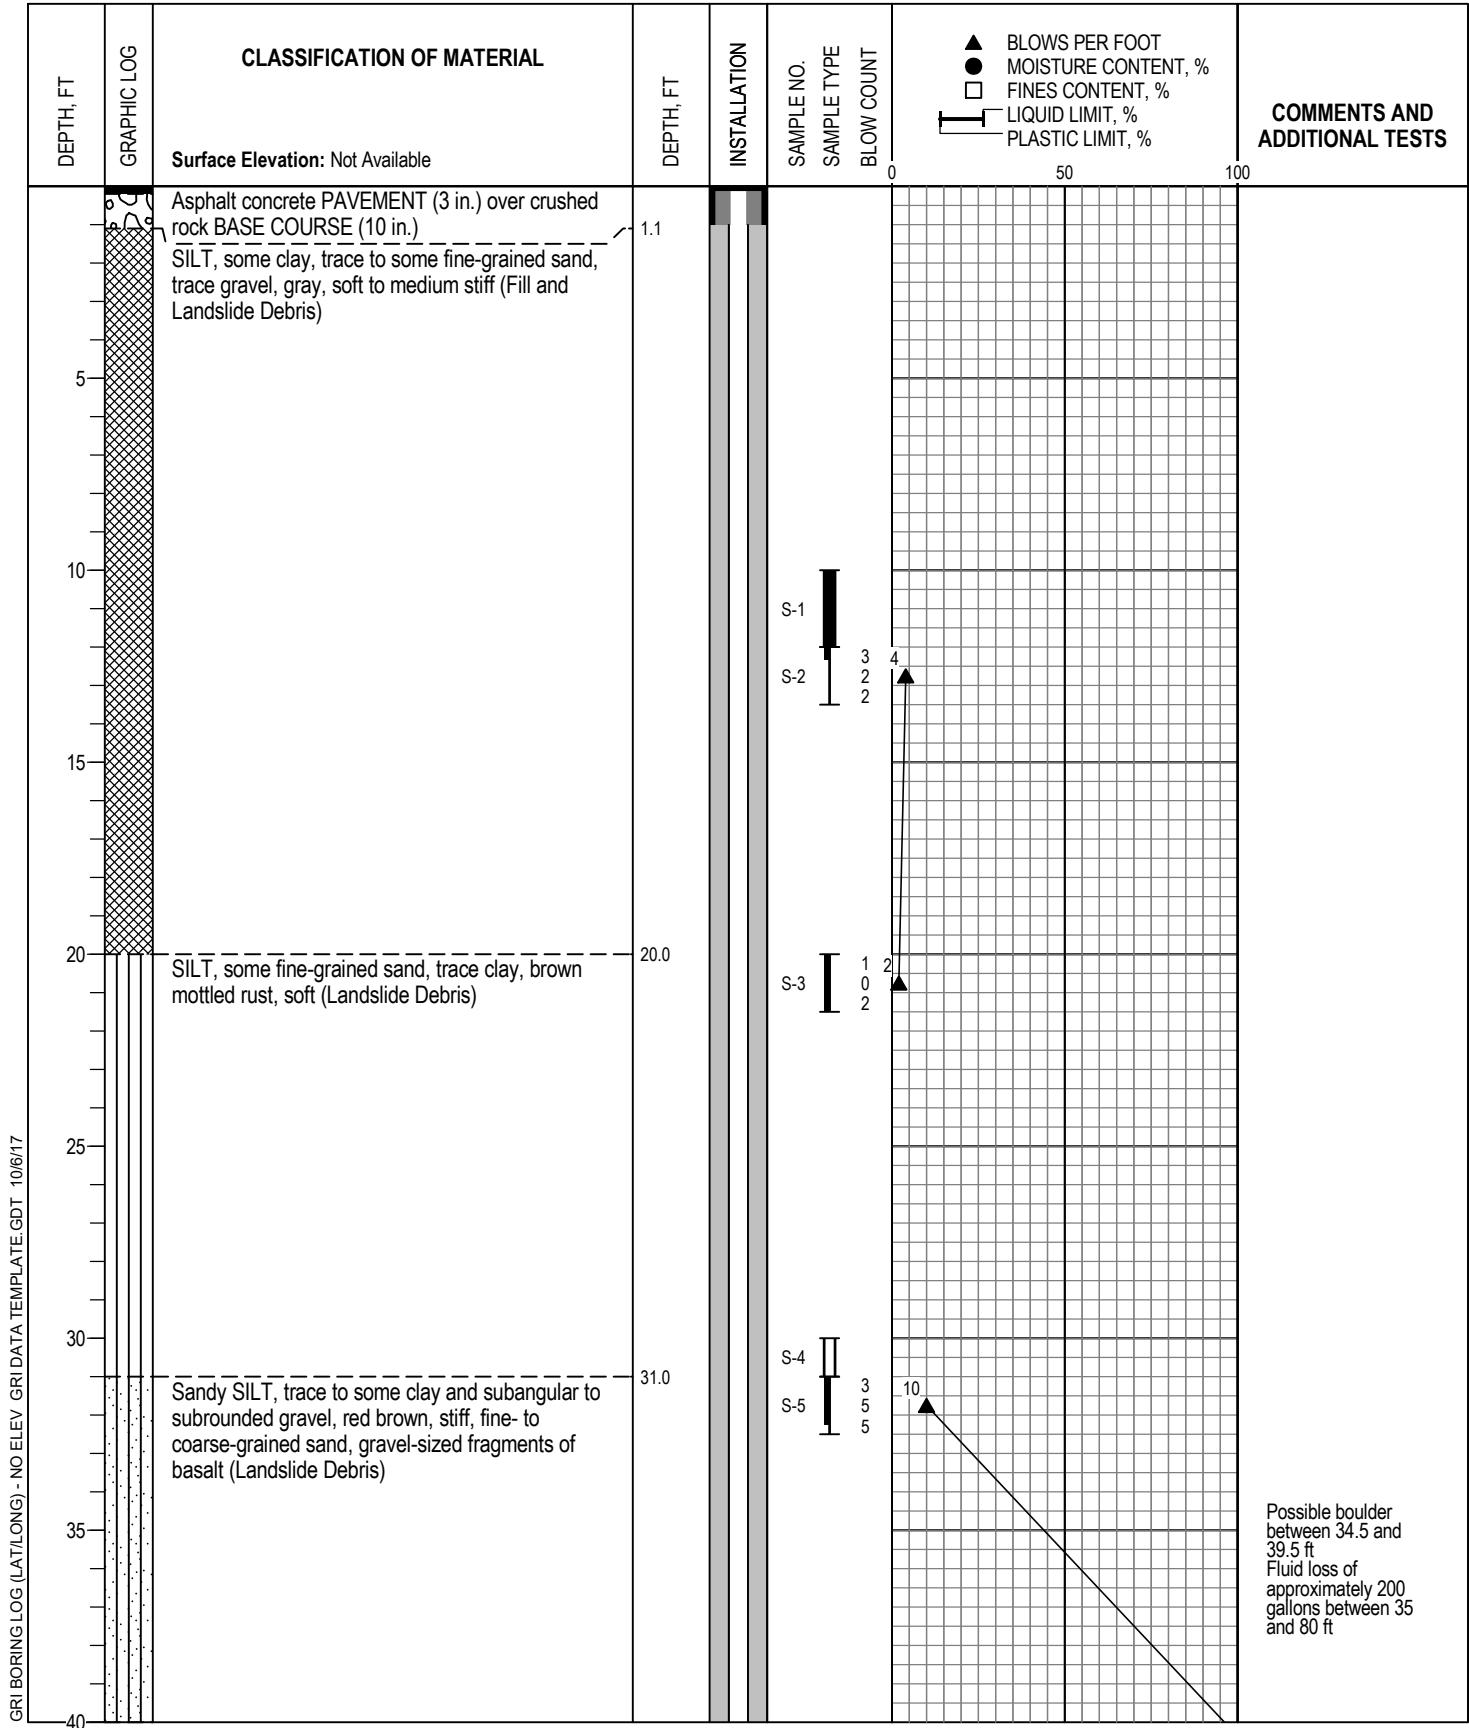
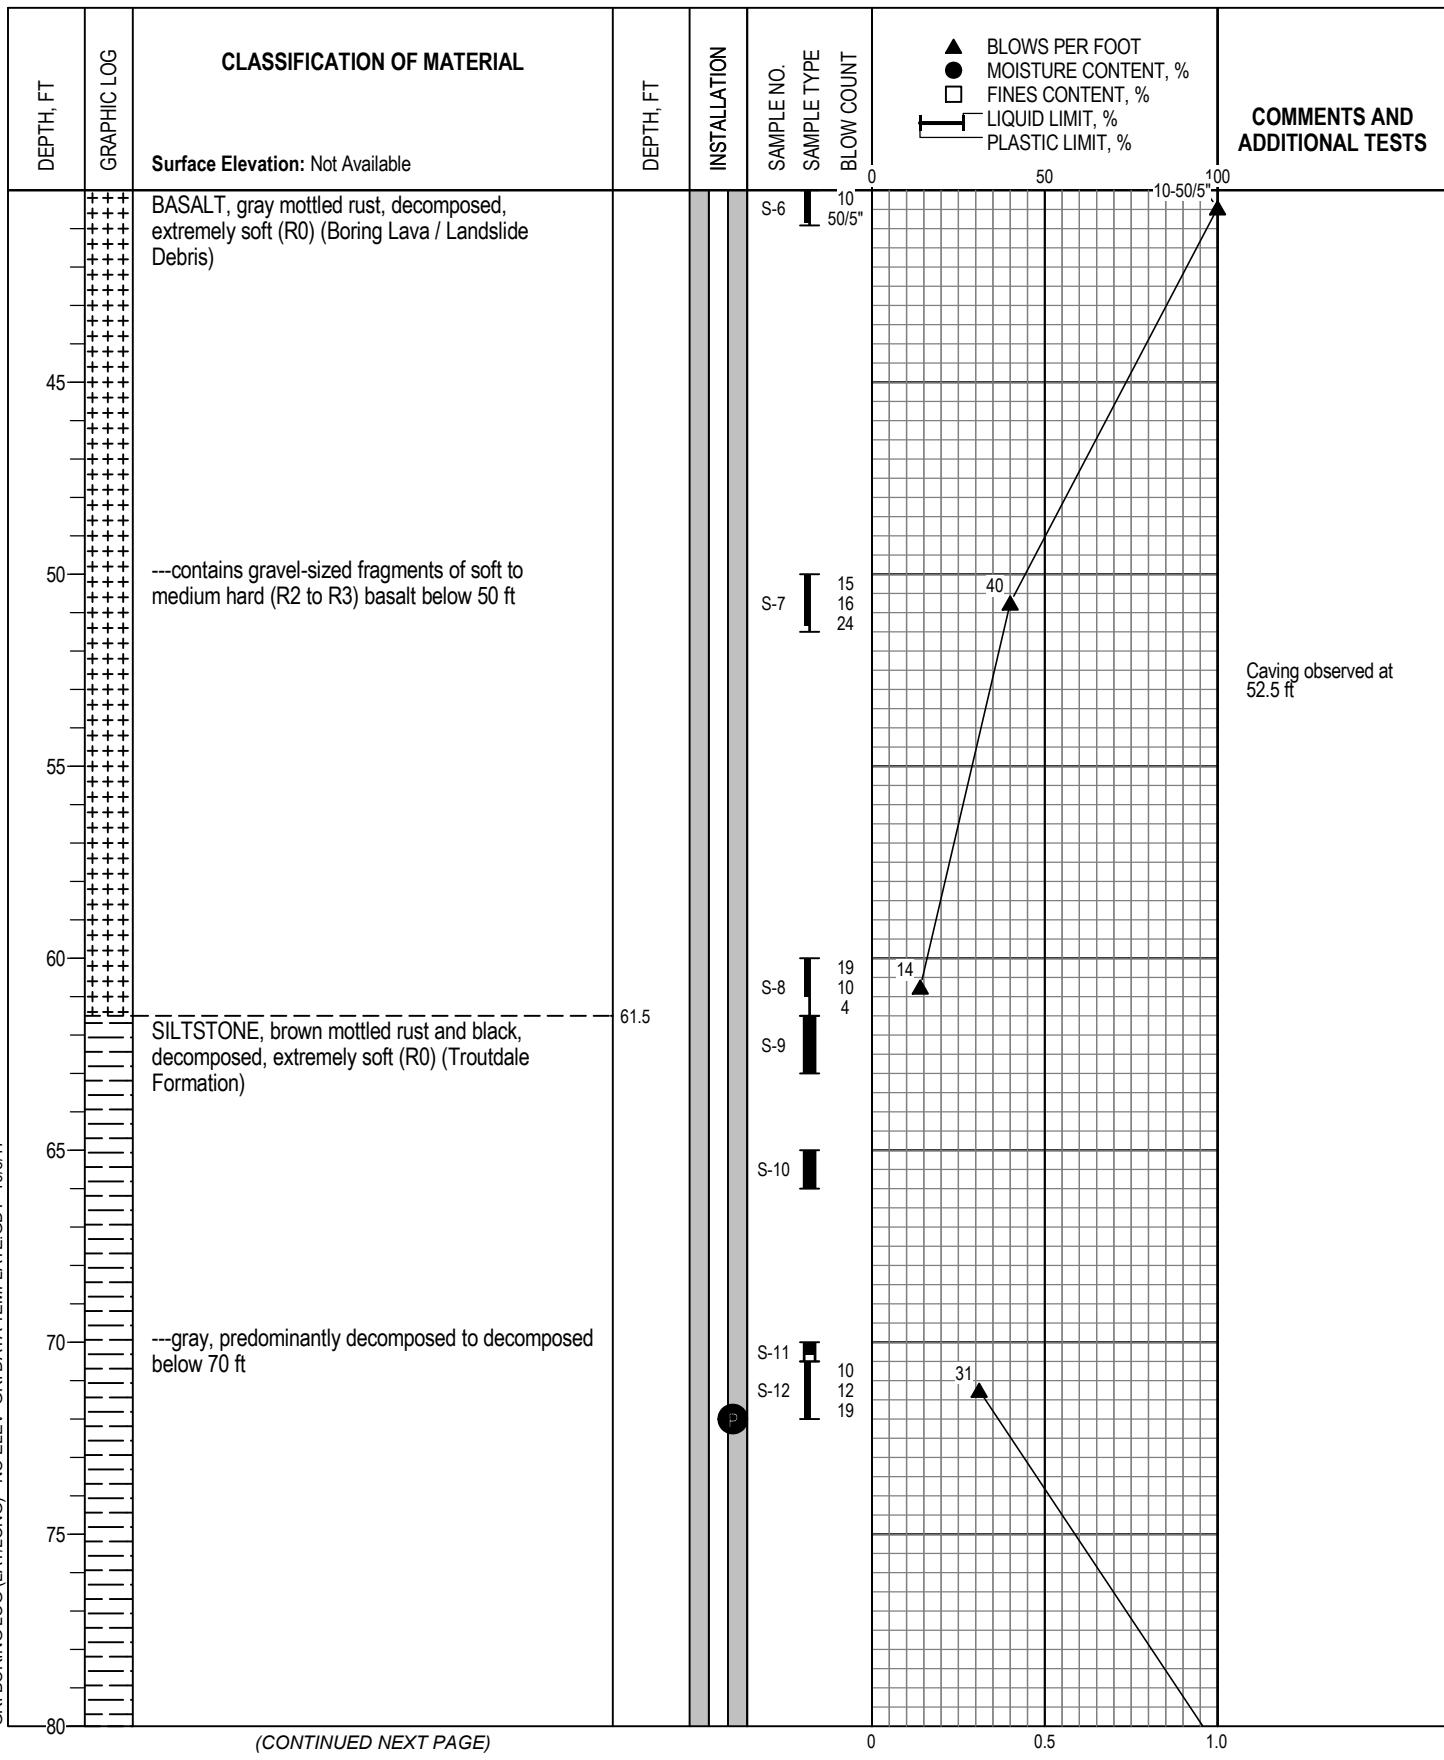
BORING B-2

4. SAND, SILT, and CLAY (Landslide Debris). The fill in boring B-2 is underlain by silt, sandy silt, and clay landslide debris. The silt is generally brown mottled rust and contains trace clay and some fine-grained sand. The relative consistency of the silt is very soft to soft based on an SPT N-value of 2 blows/ft.

5. BASALT (Landslide Debris). Extremely soft (R0) basalt landslide debris interpreted to be of the Boring Lava formation was encountered beneath the silt and clay residual soil in boring B-2 at a depth of 40 ft. The basalt landslide debris extends to a depth of 61.5 ft. The basalt is generally gray mottled rust in color and decomposed. The basalt landslide debris contains gravel-sized fragments of soft to medium hard (R2 to R3) basalt below a depth of 50 ft. SPT N-values of 14 blows/ft to 50 blows for less than 6 in. of sampler penetration were recorded in the basalt. The degree of hardness and weathering of the basalt varies with depth. Landslide debris was only encountered in boring B-2, which was drilled in Trillium Park Drive.

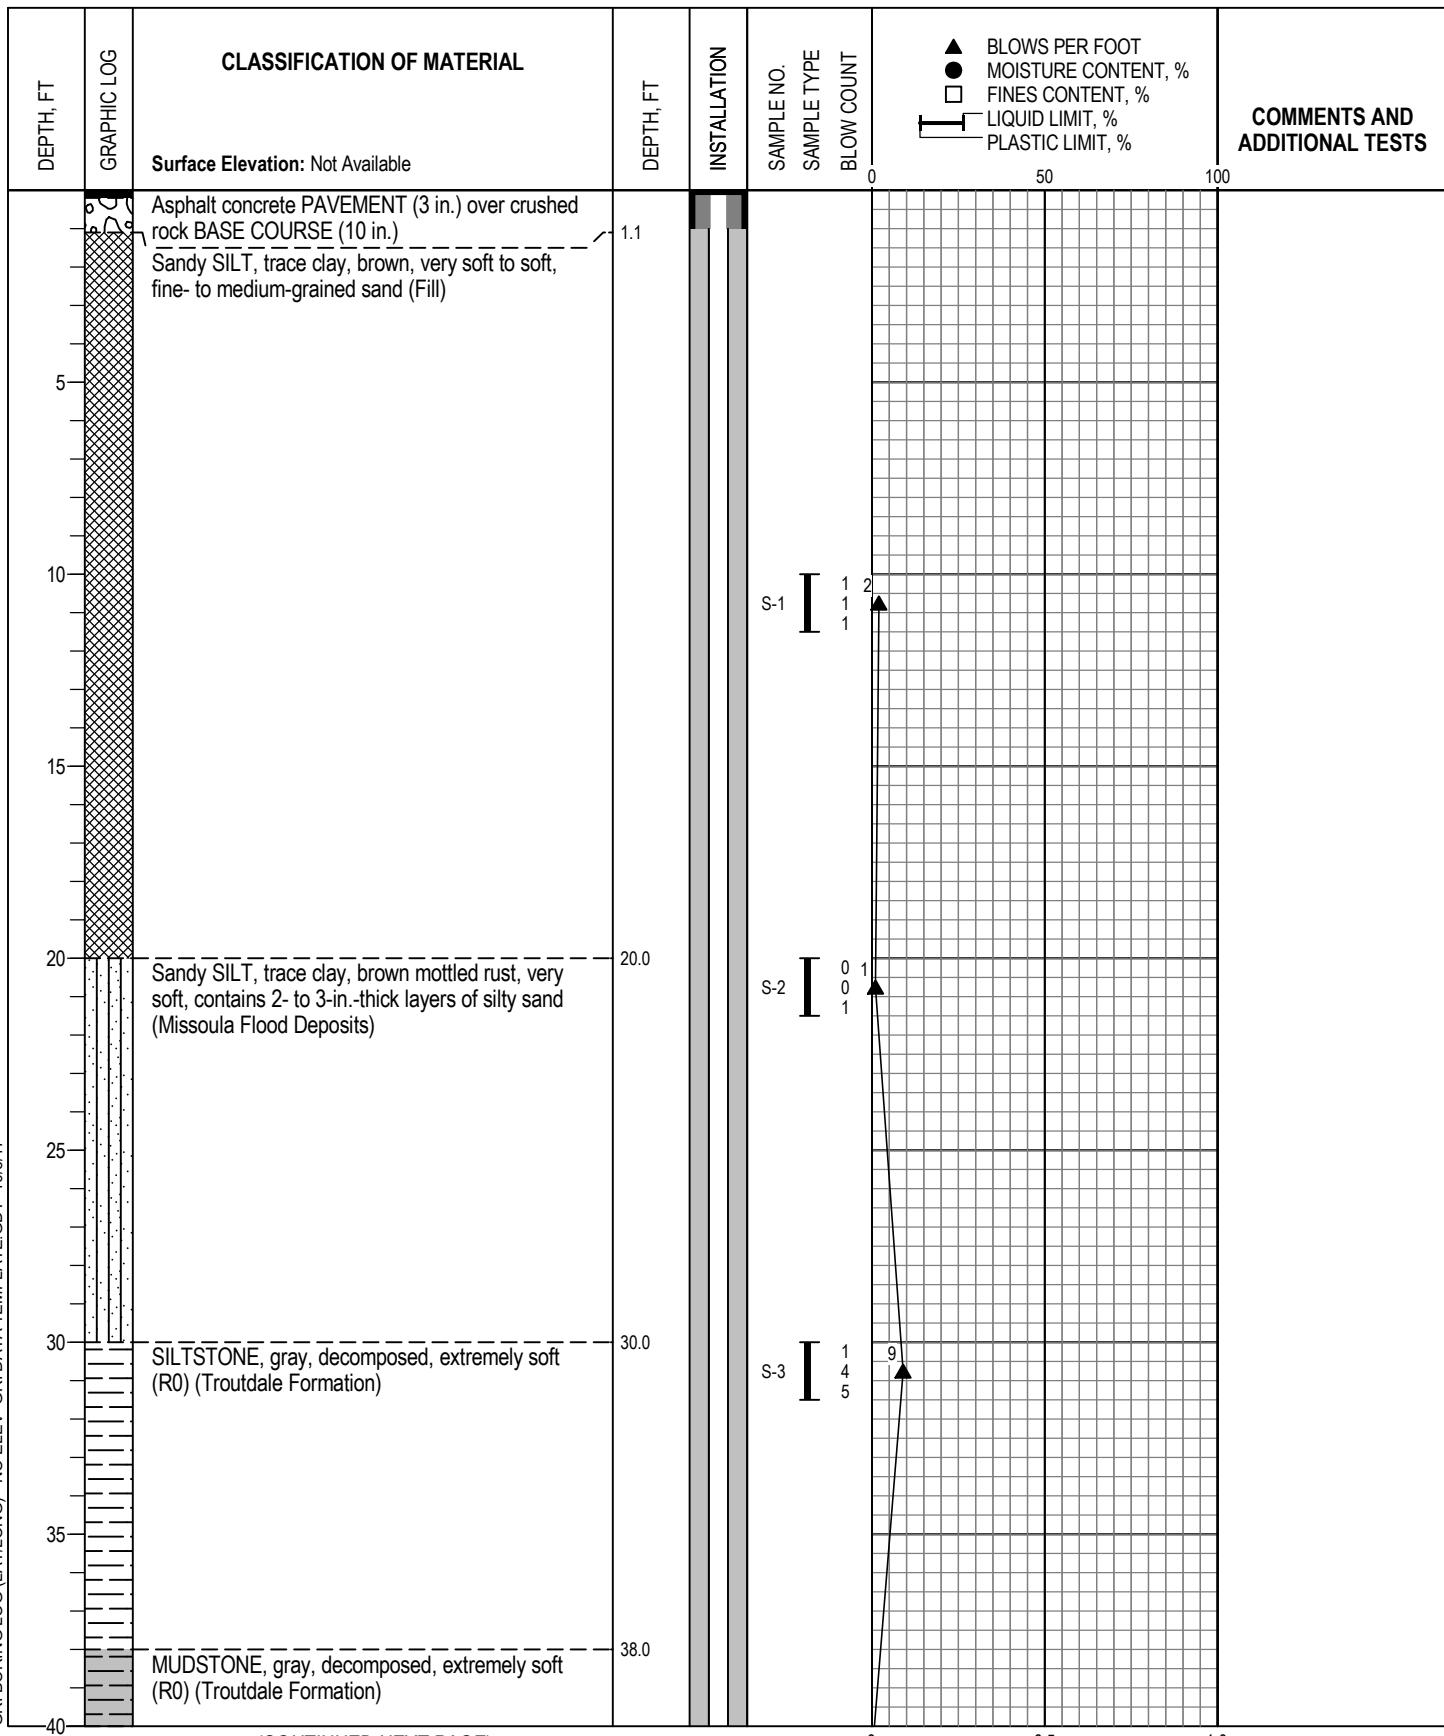
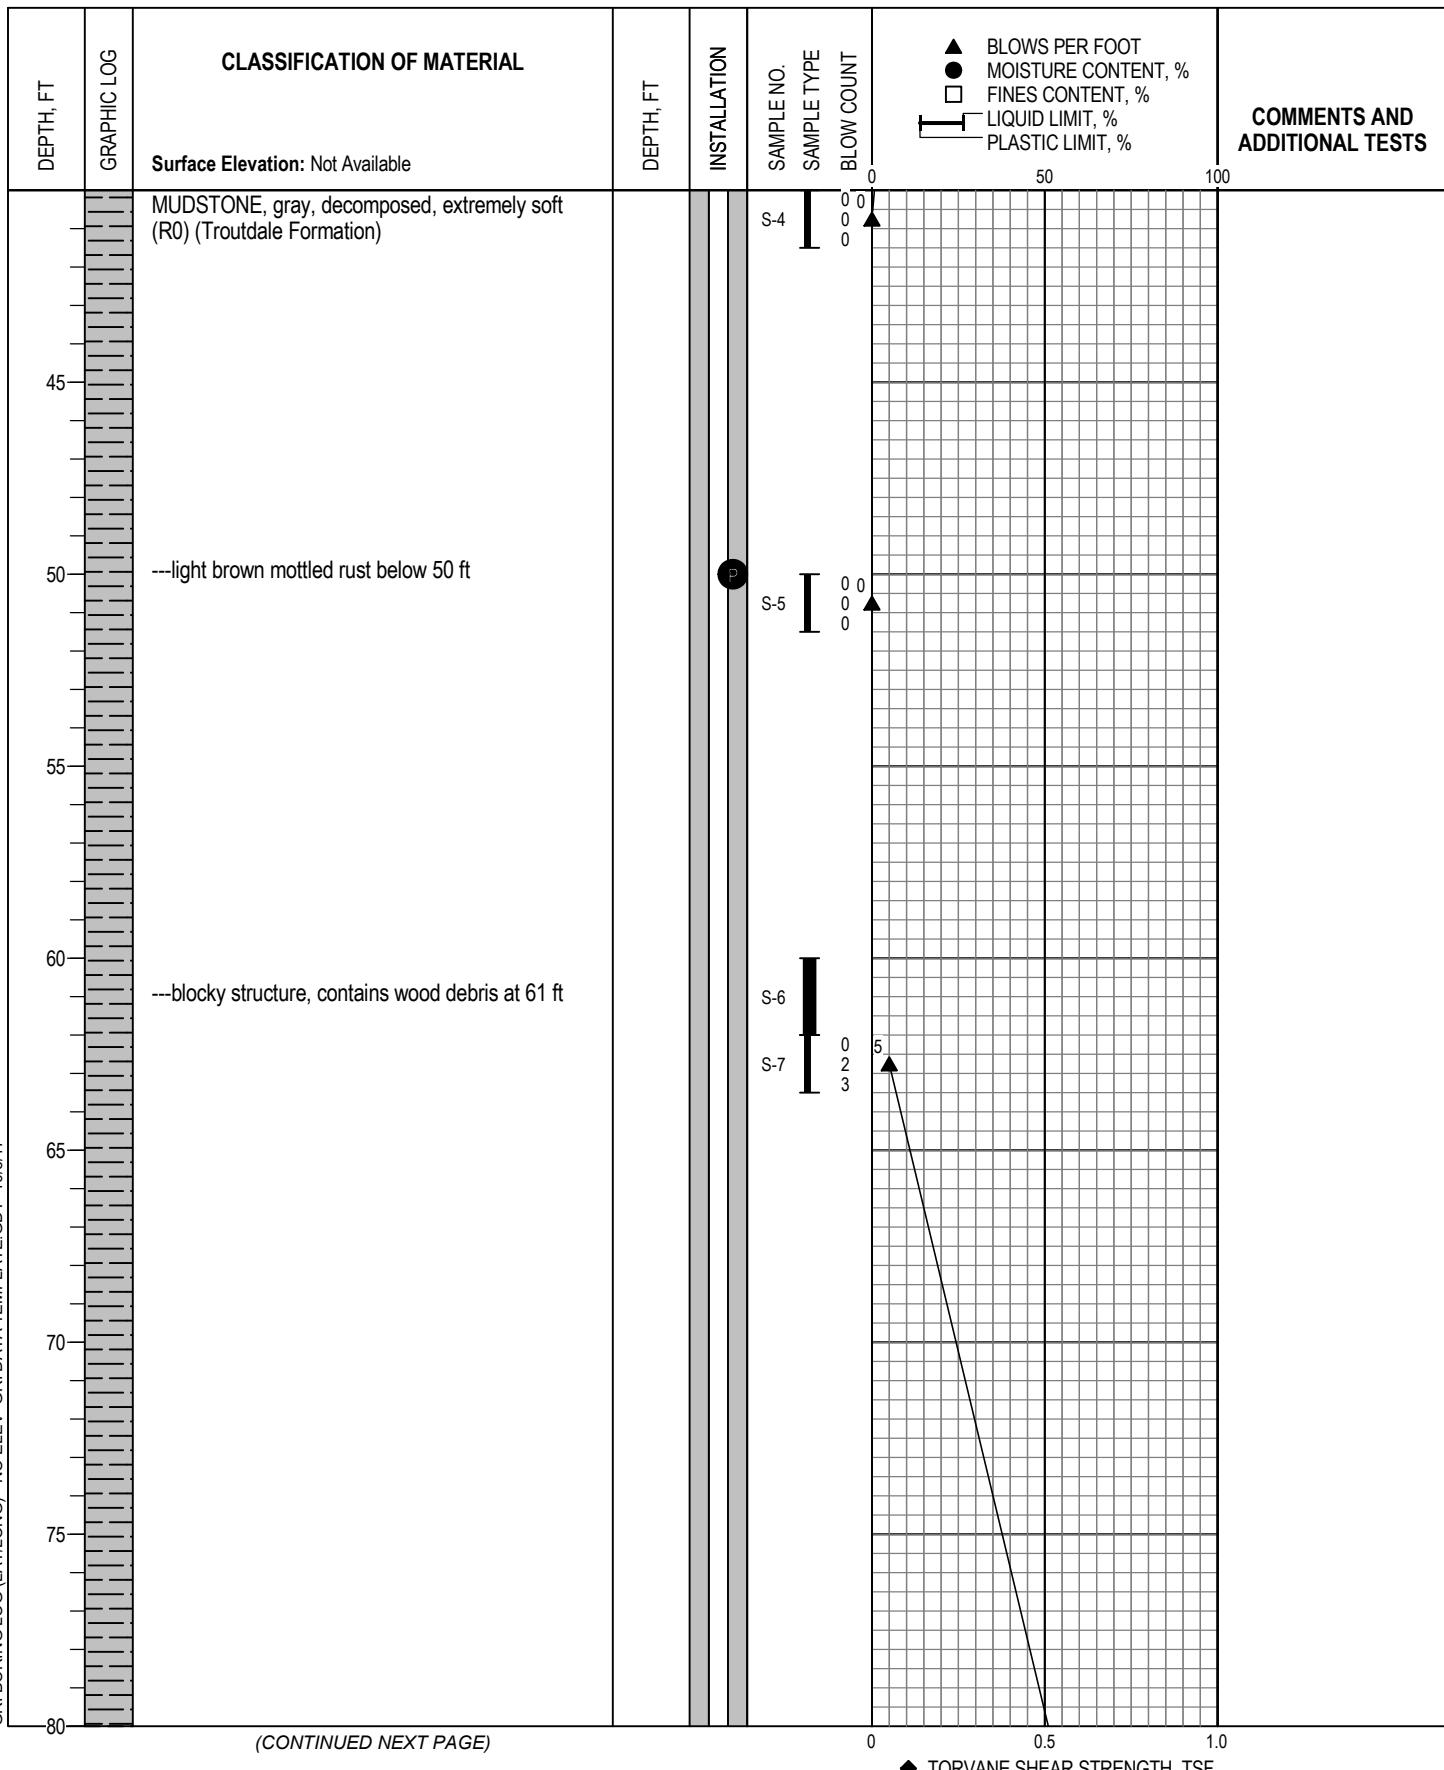
BORING B-3

3. SAND and SILT (Missoula Flood Deposit). The fill in borings B-3 and B-4 and the base course in boring B-5 are underlain by silts and sands interpreted to be material from Missoula flood deposits that extend to depths of 20 to 45 ft. The silt flood deposits are generally brown to brown mottled rust, have a variable clay content ranging from trace clay to clayey, and range in sand content from trace fine-grained sand to sandy. The silt unit encountered in boring B-3 was interbedded with 2- to 3-in.-thick layers of silty sand below 20 ft. The relative consistency of the silt is very soft to medium stiff based on SPT N-values of 1 to 6 blows/ft.
